1880s & 1890s Sandstone Quarry Locations
North Bank of Bow River, Calgary
Candidate Sites based on 1944-2021 Geotechnical Borehole Data
August 2022

**1880s & 1890s Sandstone Quarry Locations
North Bank of Bow River, Calgary
Candidate Sites based on 1944-2021 Geotechnical Borehole Data**

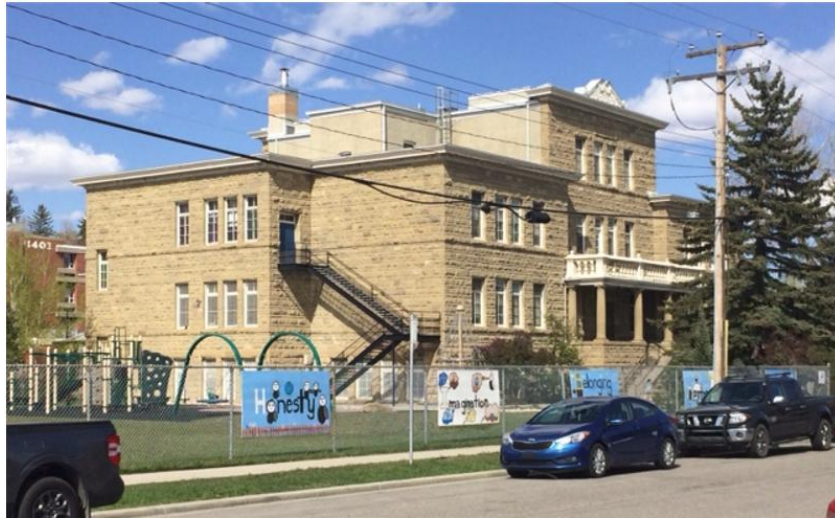
Figure 8. Hillhurst School. Built in 1912, it was one of the last of the sandstone schools to be built. The sandstone blocks are of uniform size in comparison to the 1890 courthouse.

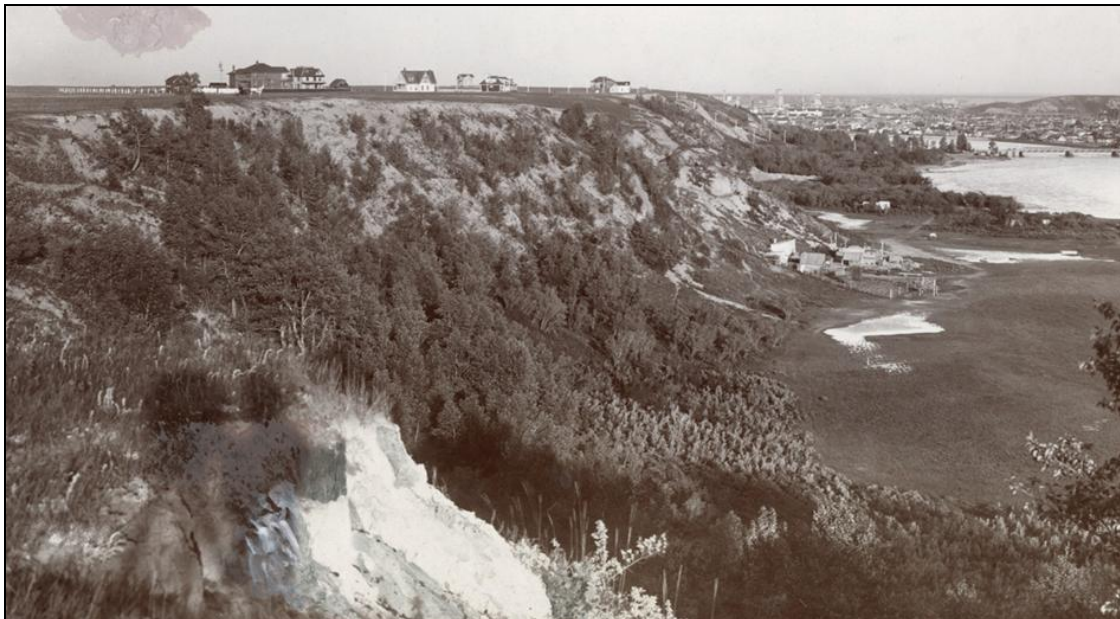
Figure 9. "View of Bow River Looking East, Calgary, Alberta", (ca. 1908), (PB-12-39), by Unknown. Courtesy of Glenbow Archives, University of Calgary. Photo looking east taken from Crescent Road and 5th St. N.W. McArthur Bridge, where Centre St. Bridge is currently located, is visible in the distance. A complex of eight buildings is visible in the mid-distance at the base of the escarpment slope.

What makes the slope alteration hypothesis compelling is the 1908 photo of McHugh Bluff shown previously in Figures 9 & 10. Those photos shows a bench cut into the slope and a number of buildings below. The quarry operated for at least three years (1888-1890), if not longer, indicating a significant volume of sandstone was removed. Perhaps quarrying began at the western end of the bedrock outcrop at ~3rd St. N.W. where some buildings were constructed and then proceeded east towards Centre Street, where borehole data indicates sandstone was present. The commercial sandstone beds were likely present in discrete 50 - 75 metre long segments over this distance with a series of quarries distributed along the base of the escarpment. Perhaps with the stone moved back to the original site at 3rd St. N.W. for finishing.

Another interesting outcome of the research is the possibility of north bank claystone quarries. Sandstone quarrying has been the focus of most historical research. Claystone quarrying for brick making has fewer references. Two claystone leases were opened on the north shore of the Bow River at a time a brickyard was operating in Bridgeland. More historical research is needed to determine from where the clay for the brick making was sourced. Perhaps this search will shed light on the story behind the buildings at the base of the escarpment located at 3rd St. N.W. in the 1908 photo (Figures 9 & 10).

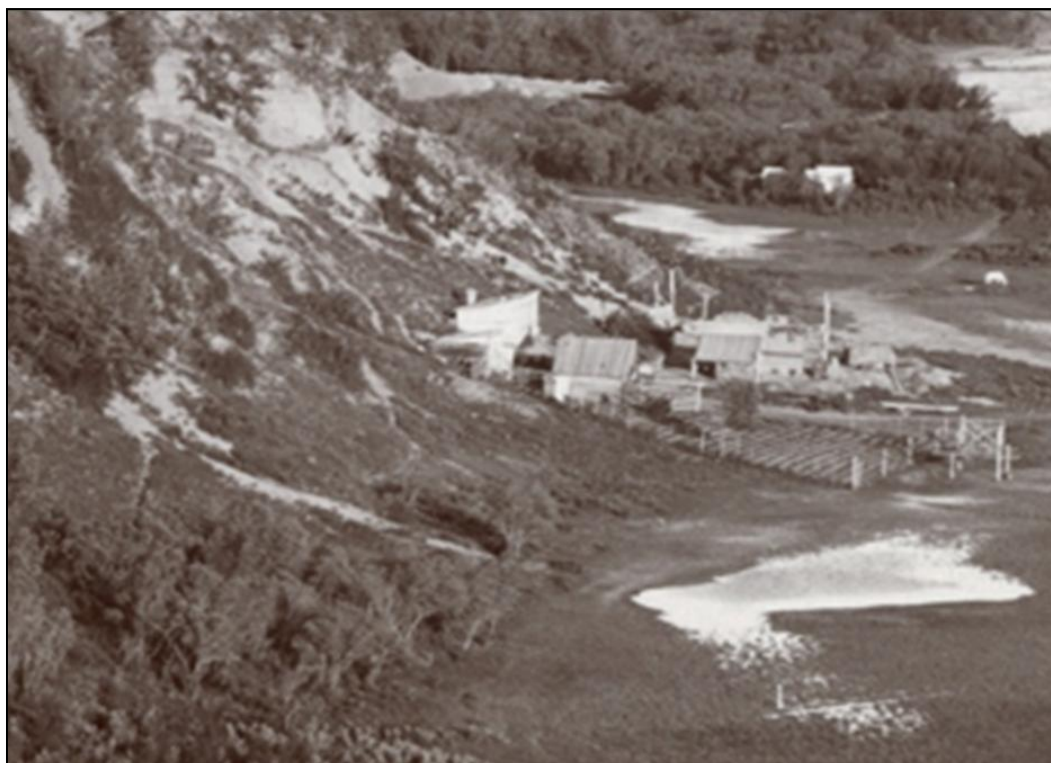
Figure 10. A zoom-in of figure 9 photo of buildings located at base of slope with a horizontal bench cut further up the slope. Further east, beyond the first trees, there is another light-coloured debris slope that may indicate quarrying above.

The 1908-photo building complex plots as being at a base of slope site north of the Sunnyside Housing Co-op at 3rd St. N.W. A base of slope fan cone visible in the 1908 photo appears to be present today, cut by the diagonal walking path. A few years after the 1908 photo, the City tramline was running right by this spot, as it climbed-up the hill to Crescent Road, using the high angle walking path visible in the satellite image.

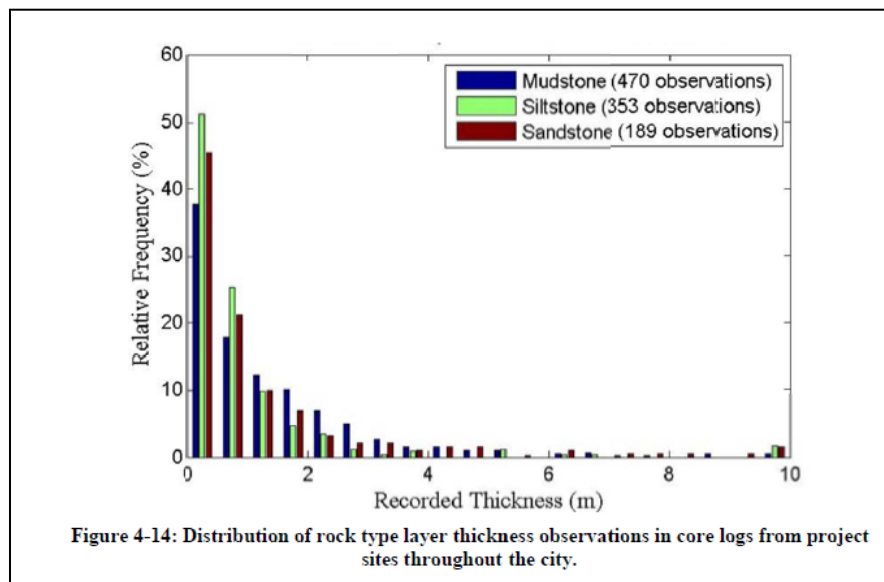
Figure 4-14: Distribution of rock type layer thickness observations in core logs from project sites throughout the city.

Figure 14. From Crockford, A. 2012, showing Paskapoo bed thickness encountered in geotechnical boreholes in Calgary. Sandstone bed thicknesses greater than 2 metres are rare.

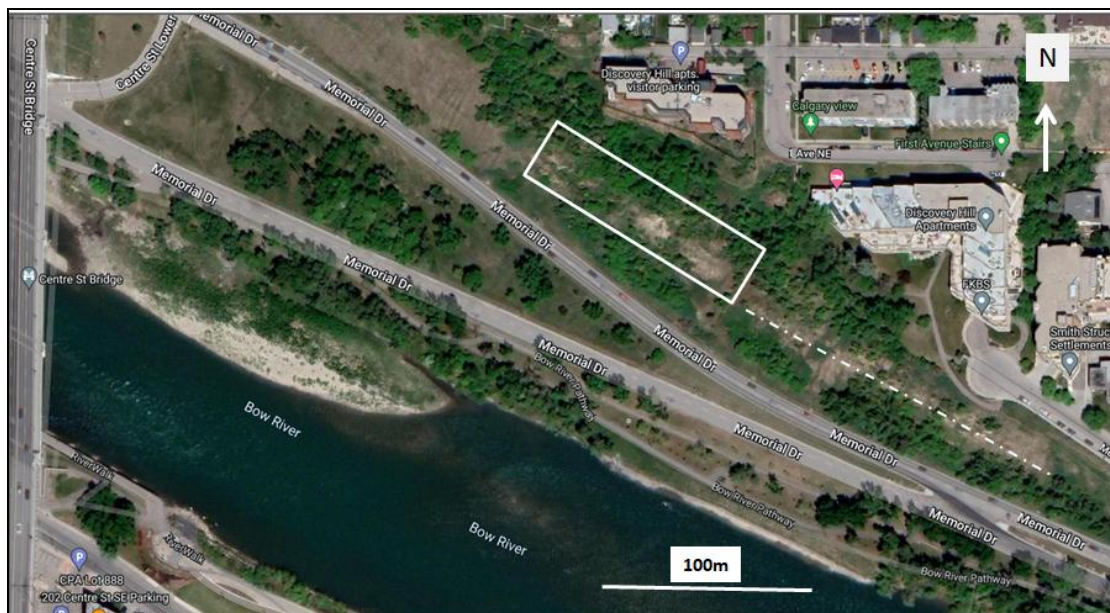
Figure 15. Satellite photo of East Crescent Heights Escarpment. The dashed line shows where a band of bedrock is exposed about 10 metres vertically above the base of slope. The white rectangle encloses an area of slope modification, perhaps indicative of excavation of a quarry bench.

The location of the bedrock outcrop is shown by the dashed line on the satellite image below. Exposure occurs in patches along the steepest portion of the bluff amongst the bushes, trees and grass. Further west, within the rectangular box on the satellite image, the slope has been altered and is characterized

by a series of bowls in the basal glacial sediments. Bedrock is not exposed. The slope bowls may indicate places where there was quarrying and overburden needed to be removed in order to expose the bedrock further into the hill. Further west yet, there are grass slopes associated with Centre Street bridge engineering with no trace of the original topography remaining.

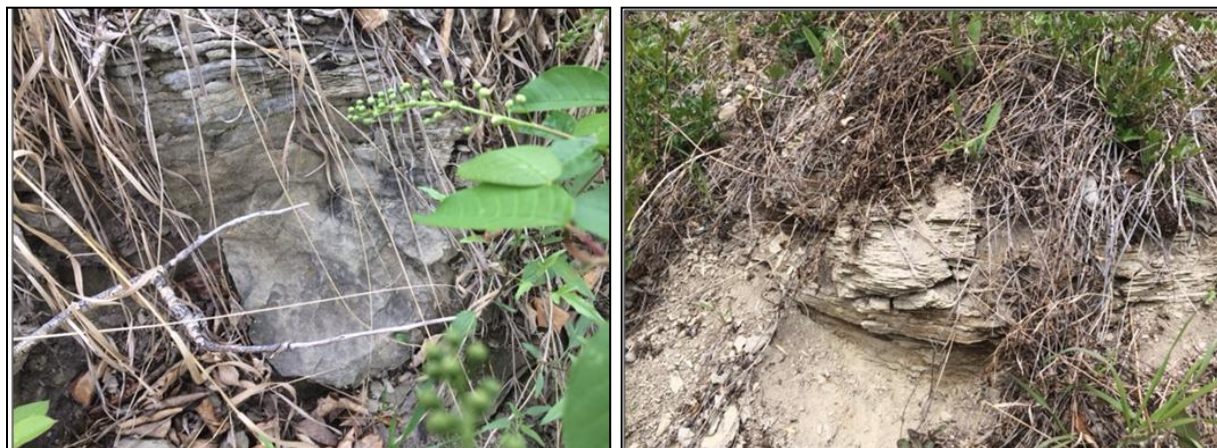
Figure 16. Outcrop at the east end of the bedrock exposure. Grey, finely laminated claystone and a laminated crumbling, brown siltstone.

Grey claystone and thinly laminated siltstone are found at the eastern portion of the outcrop band, as shown in the photos below. The bedrock is heavily weathered, crumbling when picked-up.

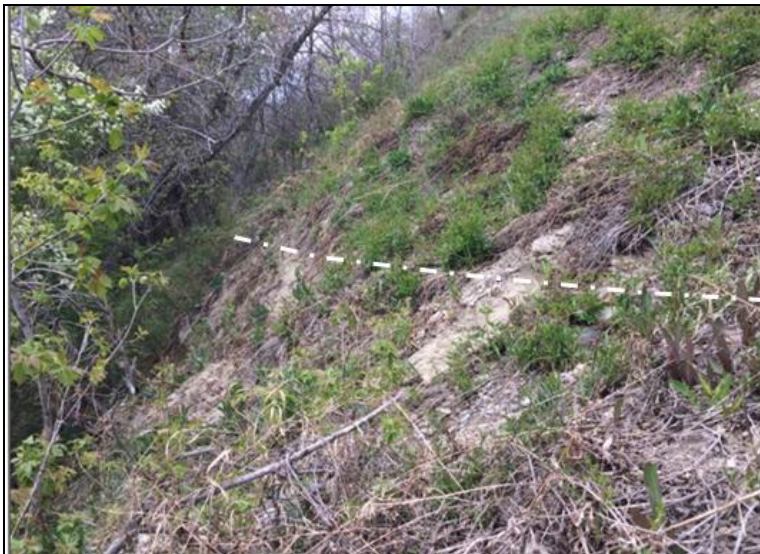
Figure 17. Photo of slope angle change. The white line marks where bedrock is found at outcrop with glacial sediments above. The angle of the slope lessens above this line.

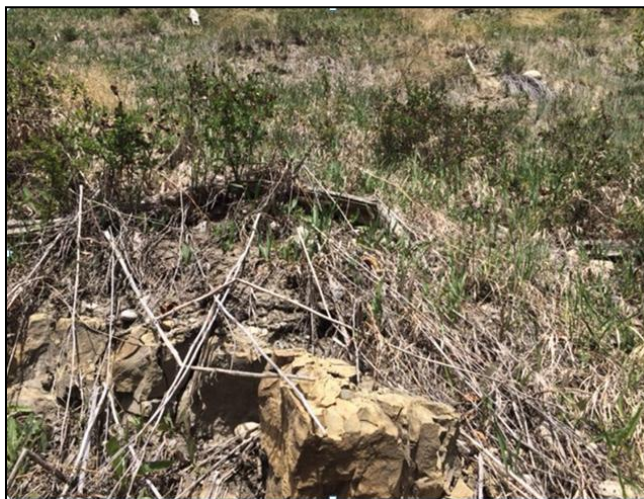
Figure 18. Photo of yellow, blocky sandstone at west end of outcrop band. Sandstone bed is about 0.2 metres thick.

Blocks of sandstone are found in places at the base of the slope. They may have been displaced from further up the hill; perhaps even due to quarrying operations. One small band of sandstone was found at outcrop near the west end of the exposure as shown in the photo below. It exhibits the characteristic yellow colour of the Paskapoo Sandstone. Immediately above this outcrop the slope has been excavated and is a bowl shape. Perhaps there was quarrying here and the bowl is due to glacial sediment overburden removal.

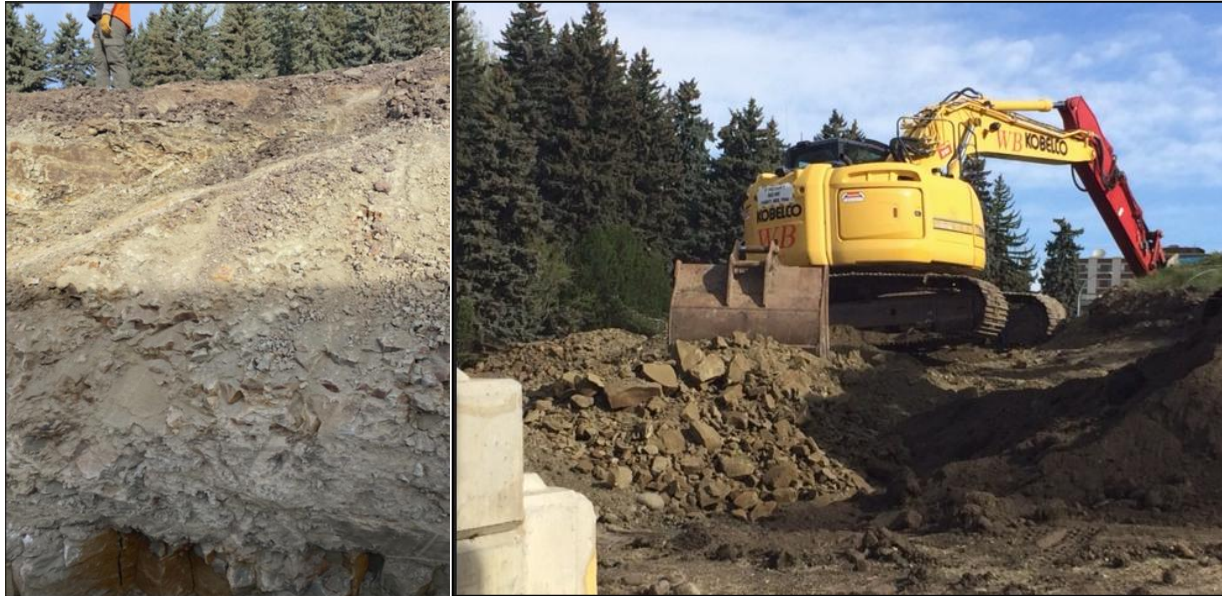
Figure 19. Excavation pit photo at base of 10th St. N.W. hill for the upper plateau storm water diversion tunnel. The very bottom of photo on left shows pit walls of yellow coloured sandstone below grey coloured claystone. Photo on right shows yellow sandstone rubble lifted out of pit. Thanks to Theo, site supervisor, for photos.

Geotechnical boreholes drilled below the L.R.T. tracks for the upper plateau storm water diversion along 10th St. N.W. indicate top bedrock is ~8 metres above the Sunnyside ground level and that sandstone is present near the top of the bedrock (section 3.4 below). The excavation pit for the tunnel entry was opened in June, 2022 and during a walk-by, yellow coloured sandstone blocks were noticed in the mound of material dug out of the pit. The site foreman was kind enough to take a photo of the pit when requested.

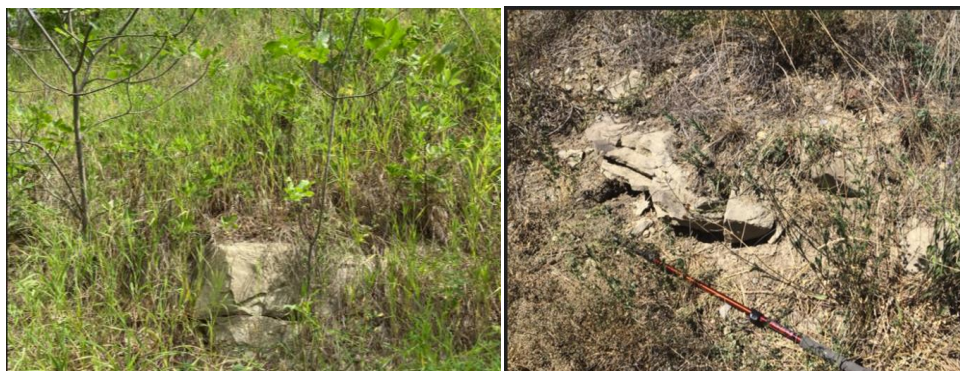
Figure 20. Two of the several small sandstone/siltstone outcrops at ~1059 metres a.s.l. elevation found between 9A St. N.W. and 7th St. N.W. Left photo courtesy of Peter Hews.

East of the tunnel excavation, along the ~1059 metres a.s.l. elevation contour (± 1 metre) between 7th St. N.W. and the candidate 9A St. N.W. quarry site (section 3.2), five small outcrops of sandstone/siltstone are found on the steep slope. Finding five such exposures along a 125 metre long slope segment at the same elevation as the top bedrock elevation in the nearby escarpment boreholes indicates these are valid near top bedrock outcrops and not construction blocks displaced from above. The easternmost bedrock exposure is 50 metres east of the path that climbs from Sunnyside to 7A St. N.W. in Rosedale.

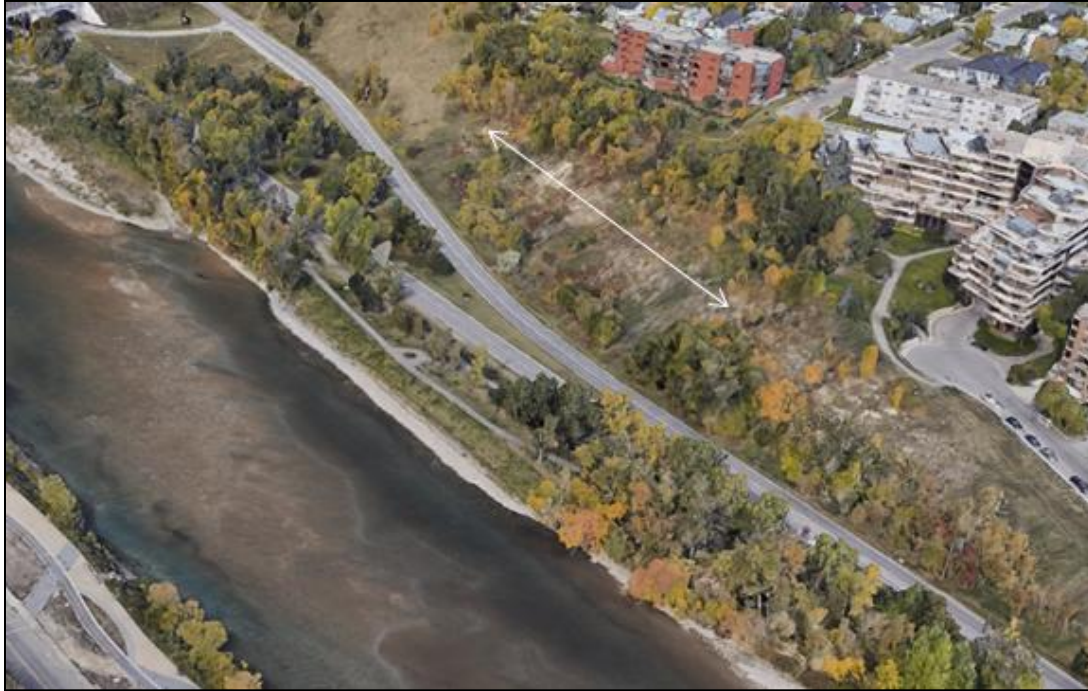
Figure 26. *Satellite Image of slope above projected sandstone outcrop. The slope has been extensively reworked with flat spots and bowls on slope above the top bedrock elevation. This is consistent with overburden removal in the building of a quarry bench back into the hill. The arrow shows the extent of the slope reworking.*

The arrow in Figure 26 highlights a stretch of alterations to the glacial sediments in the slope above a projected sandstone outcrop. Iron cable and poles were found at one slope break location. The east end of the arrow marks the start of the claystone outcrop segment. The west end marks the severe slope modifications that were part of the building of the Centre Street Bridge. The west end of the arrow is also, coincidentally, the boundary of the Barwis land title.

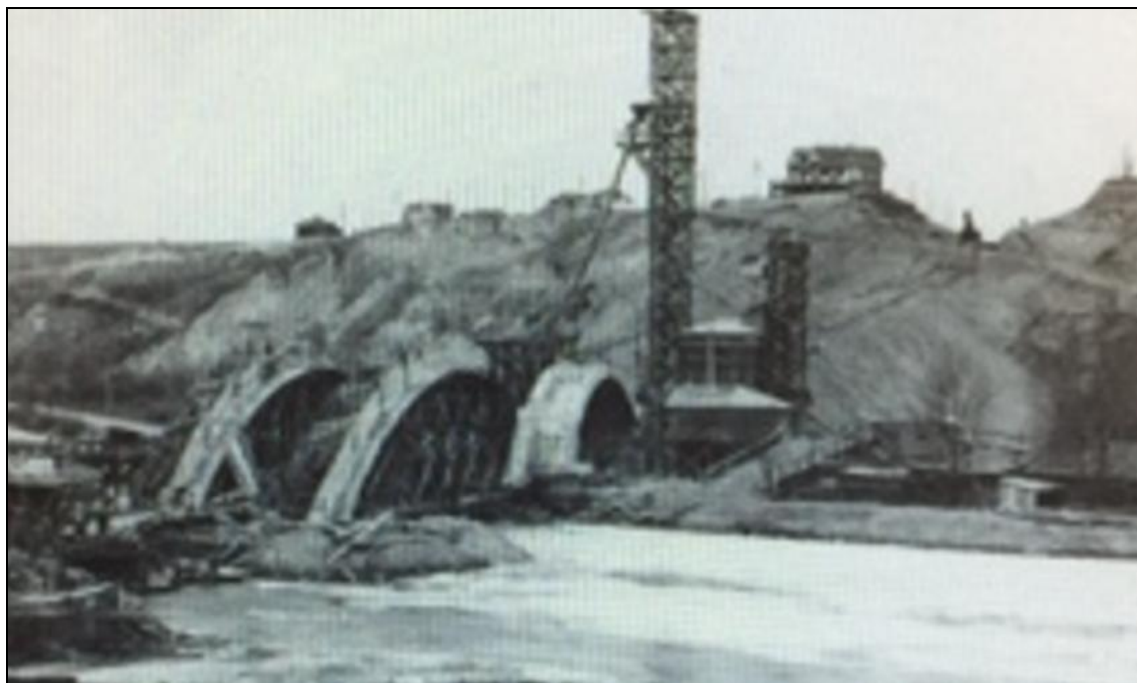
Figure 27. "The Centre Street Bridge, Calgary, Alberta", (July 1915), (NA-2782-4), by Unknown. Courtesy of Glenbow Archives, University of Calgary. The slopes on both sides of Centre St. have been excavated, destroying any indications of old quarries at the base of the slope.

Figure 27 in the main document shows extensive excavation of the escarpment slope undertaken in the construction of the Centre Street bridge in 1916. After the bridge was completed, a new Sunnyside tramway was cut across the slope in 1918, at a lower angle than the original route, to intercept Centre Street just north of the bridge. The slope west of Centre Street failed in 1932, both above and below the tramway. It seems likely that the construction activities may have indirectly led to the slope failure. The City engineers could not stabilize the slope and tram cars were stopped permanently on this route.

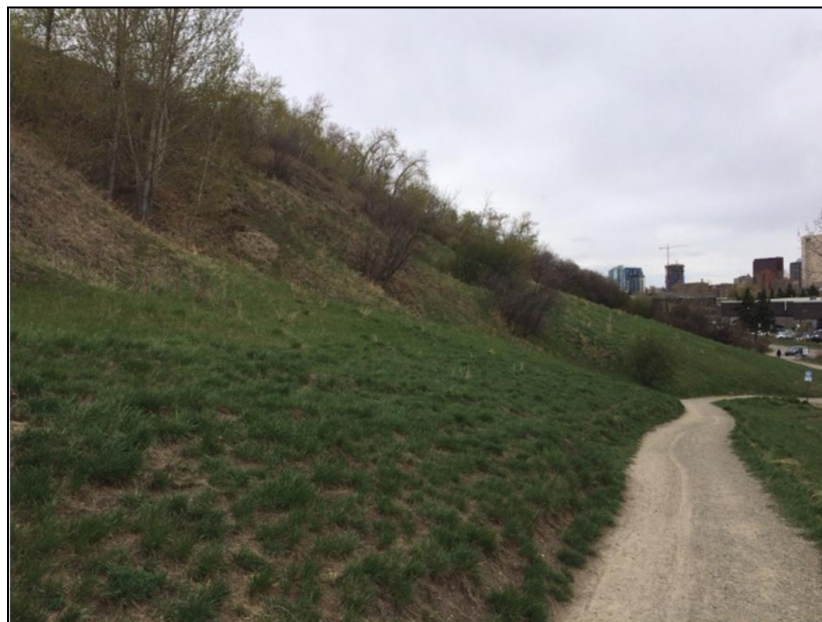
Figure 28. 3rd St. N.W. Candidate Quarry Site. Photo looking east taken from path that climbs to the escarpment. The near level line of steep faced sediments overlies a lower angle slope that may be indicative of historical quarry benches. Slope fan appears to be in 1908 photo of site.

All of this segment is the candidate site for the Sunnyside Freestone Quarry. The westernmost portion of the escarpment slope along this segment has been altered. There are bowls and changes of slopes located above the 8 - 10 metre-high projected bedrock outcrop. These features are consistent with excavation of the glacial sediments in order to cut a bench back into the hill to extract a flat lying sandstone bed. There are two fan cones at a lower slope angle that spill onto the river plain. These may be the sediments removed above the bedrock and then shoveled off the quarry face, even acknowledging there has likely been sliding of the slope in the decades since.

In Table 1 above, the historical, geology, and slope morphology data are listed for the candidate sandstone quarry sites discussed. There are four sites identified that were very likely sandstone quarries in the 1880s & 1890s. Strongest weighting is given to the geology and historical data. The slope morphology data is consistent with slope alteration for a quarry in three cases. The Orr and Sunnyside Freestone Quarry locations are narrowed down to segments shown on Figure 28. Very likely there were multiple 50 - 75 metre-long excavation benches within each segment.

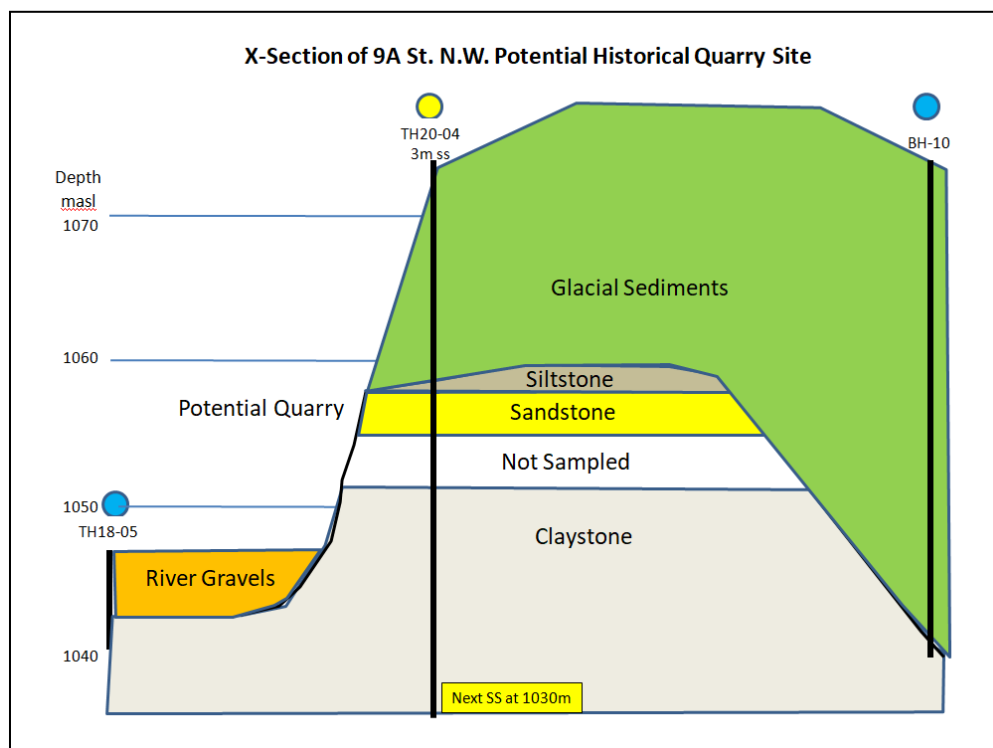
Figure 30. A cross-section of the 9A St. N.W. candidate sandstone quarry site. The location of the cross-section is shown by the red line on Figure 29.

Figure 30 above is a geological cross-section of the 9A St. N.W. candidate quarry site. River gravels overlie bedrock on the Bow River flood plain of Sunnyside. A cliff face of up to 10 metres height is shown with bedrock exposed, including a 3 metre-thick sandstone unit outcropping below a thin siltstone cap. Claystone is the most common bedrock unit. Glacial sediments that slumped down the hillside may have hidden the bedrock outcrop in places along the base of the escarpment. Glacial erosion followed by erosion of the Bow River created the abrupt change in bedrock elevation. The well, BH-10 is drilled on the escarpment rim, but the bedrock elevation is below the surface elevation in Sunnyside. This well is located on the western edge of the erosional bedrock channel that runs under the "crescent" in Crescent Road.

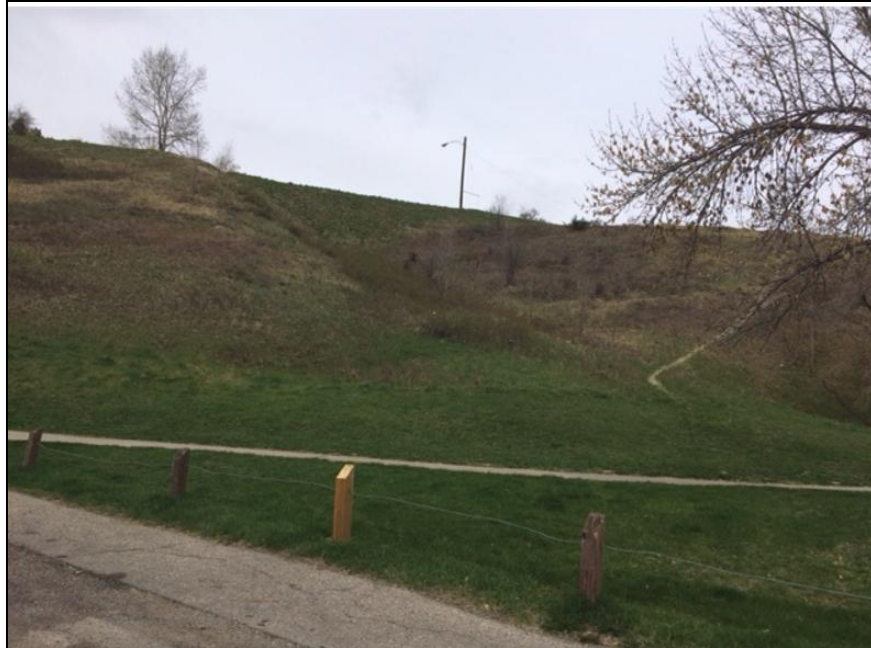
Figure 31 is a photo the hillside where a quarry site may have been located. There is a bowl in the hillside above where bedrock is projected to outcrop. The series of small bedrock outcrops are to the east of the bowl in the photo. There is a low angle fan cone below the bowl that runs to the base of the hill. These features are consistent with an old quarry site. There was a road, since converted to a path, running up the hill on the skyline. The glacial sediments excavated to build the road may have been dumped down the slope, so the slope alterations are not necessarily due to quarry operations.

Figure 31. Photo of candidate 9A St. N.W. Quarry Site. Photo is looking north from path at base of hill towards depression in slope. The geotechnical borehole that encountered 3 metres of sandstone near the top of the bedrock was drilled along the pathway up the hill, approximately where the light pole is silhouetted on the horizon.

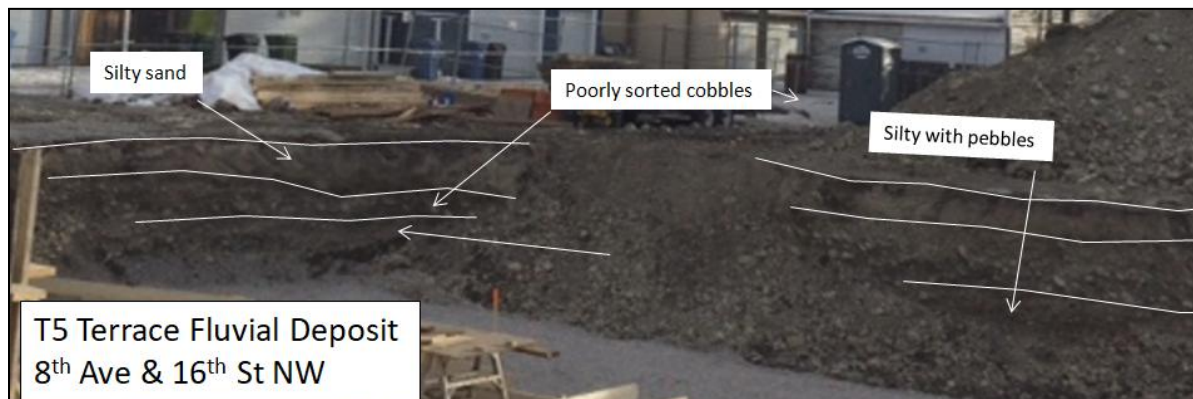
Figure A2. A 2022 photo of a construction site located at 8th Ave. & 16th St. N.W., just south of the base of the escarpment. The cobbles and pebbles are river gravels associated with the T5 River Terrace. The shallow silty sand layer may be glacial lake sediments that were eroded from the adjacent escarpment.

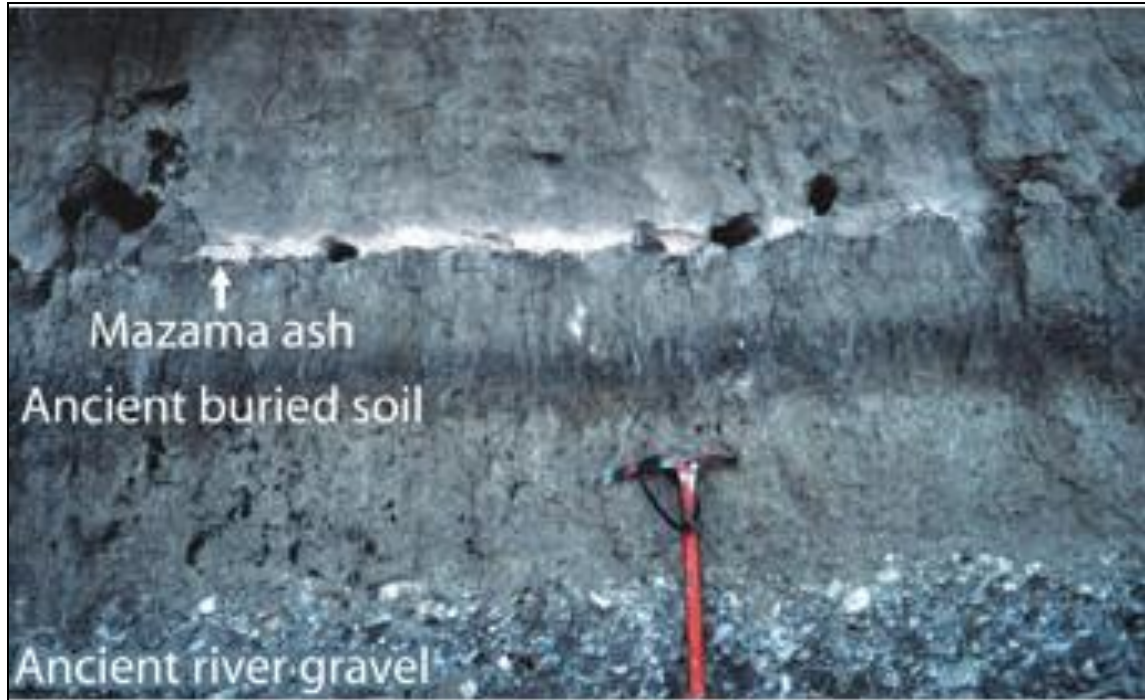
Figure A3. CGEN Website Photo. Mazama ash layer exposed along Fish Creek bank in Calgary.

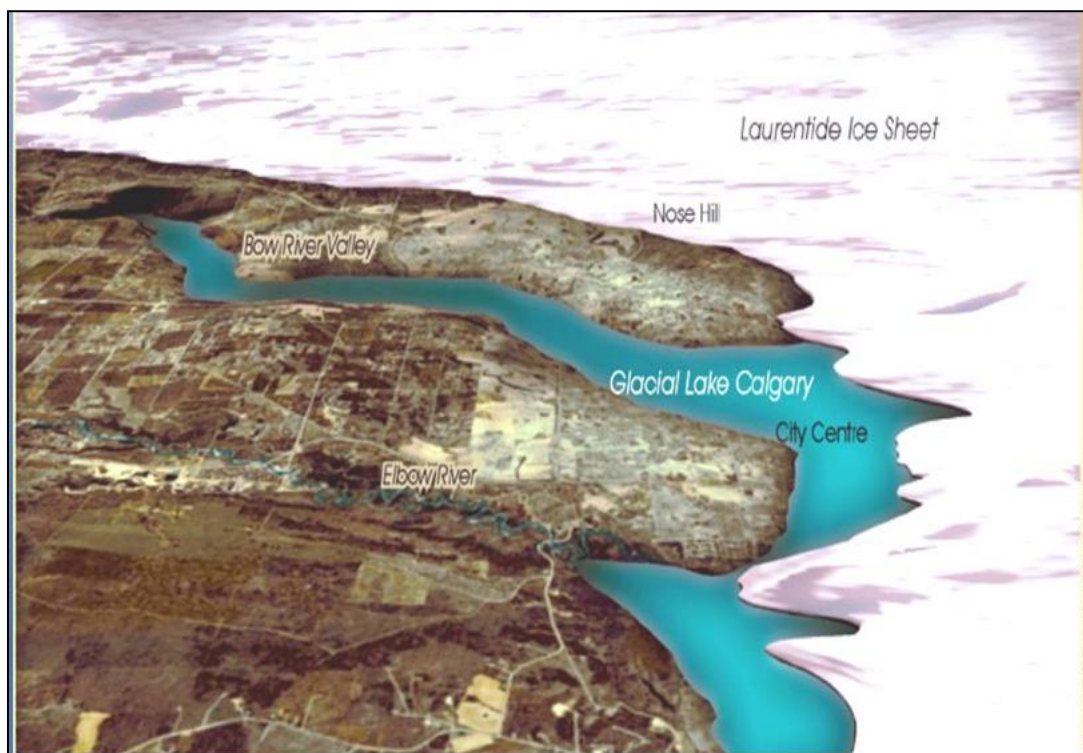
Figure B1. Glacial Lake Calgary was 100 kms. in length (GSEC Network).

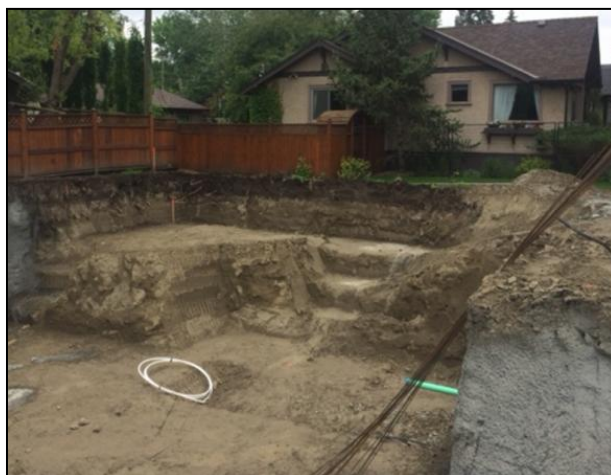
Figure B3. Sandy glacial lake sediment in a 2022 house excavation at 6A St. N.W. and Alexander Crescent. No evidence of Mazama Ash in this photo.

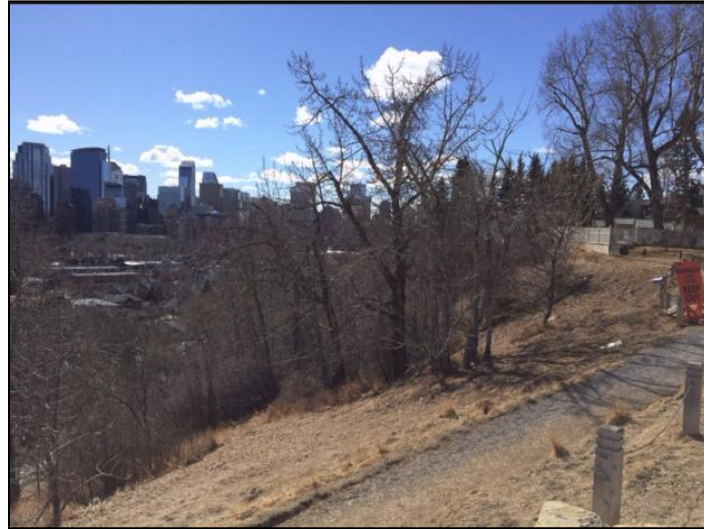
Figure D2. 2021 Photo of Leaning Trees on McHugh Bluff - an example of soil creep.

There are several types of slope failure: creep, piping where groundwater undermines a slope, debris flow, and mass slumping. Mass slumping is the most common and best explains the major slides on McHugh Bluff. Creep is evident today as shown by the photo below where the trees lean down slope. Piping beneath the shallow sandy layer, especially where associated with frost at the slope face, was common along the escarpment prior to the reduction of slope angle and gravelling of the surface. Frost activity year after year weakens the sediments on the portions of the slope face where steep slope angles are still present, such as along the east and south side of the 7A St. N.W. promontory. The trees

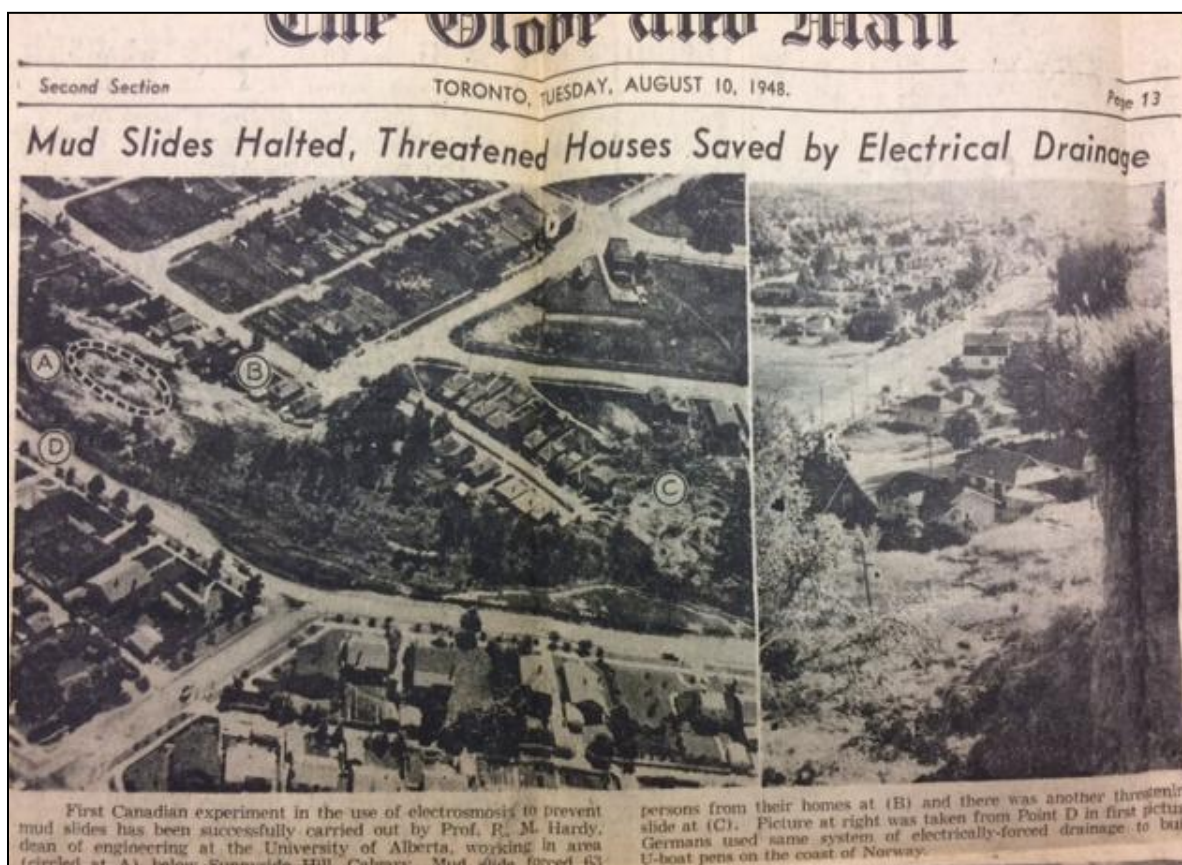
Figure D5. Calgary made the second section front page of *The Globe and Mail* in August 1948. The photo caption announces the use of electromosis to try to dry the mud flow (first in Canada). It was not effective. Only three years after WW II, an analogy is made to U-boat pens in Norway to hook the reader.

Similar to 1932, the local residents thought the water was coming from leaking City water pipes. This theory was discounted by the report engineering author, Hardy, who thought it was due to a rise in ground water. It was discovered that several of the houses on Crescent Road still had septic tanks, having being built before services were installed this far west in Rosedale. Leaking tanks were a concern, but unlikely to have been a significant contributor to the slides. Electromosis (running a current laterally through mud) was used to try to dry the mud flow. This was the first use of this technology in Canada, hence the Globe and Mail story. It was later concluded to not have been effective.

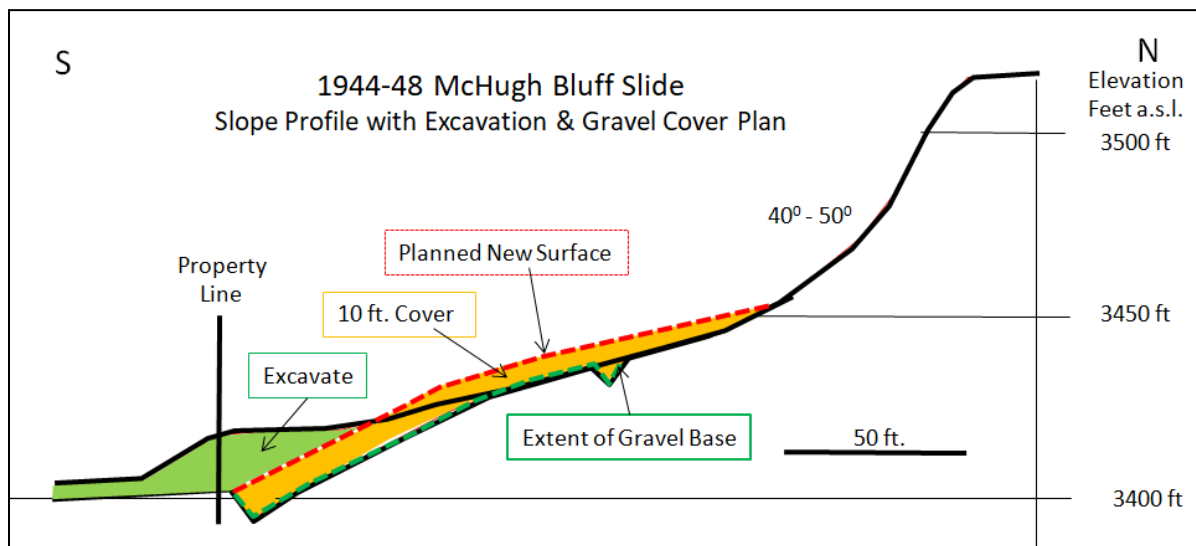
Figure D6. Slope Profile after 1948 Slide showing plans to excavate and place gravel cover. Wells were also drilled into the slope to monitor water levels.

The engineering consultants came up with a plan to prevent further sliding. They suggested putting down a sand & gravel drainage blanket (in orange in figure below), after first drying-out the silty glacial sediments using shallow wells. At the 1948 site, they planned a horizontal gravel blanket and horizontal wells for water drainage. At the 5th St. N.W. spring, located high on the slope, the plan was to install wells with pumps to depths > 20 feet. They recommended not moving the threatened 9th Ave. N.W. houses, but three years later, the City did just that.

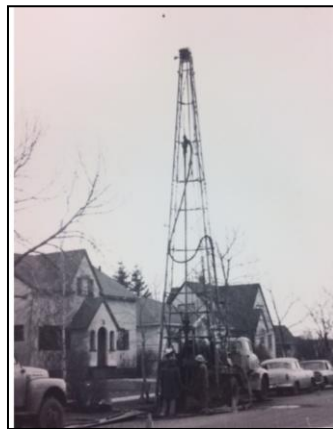
Figure D8. 1959 Geotechnical Drilling on Alexander Crescent. The same houses are still there in 2022. The City of Calgary Archives (copyright; cannot be reproduced without obtaining permission of City Archives).

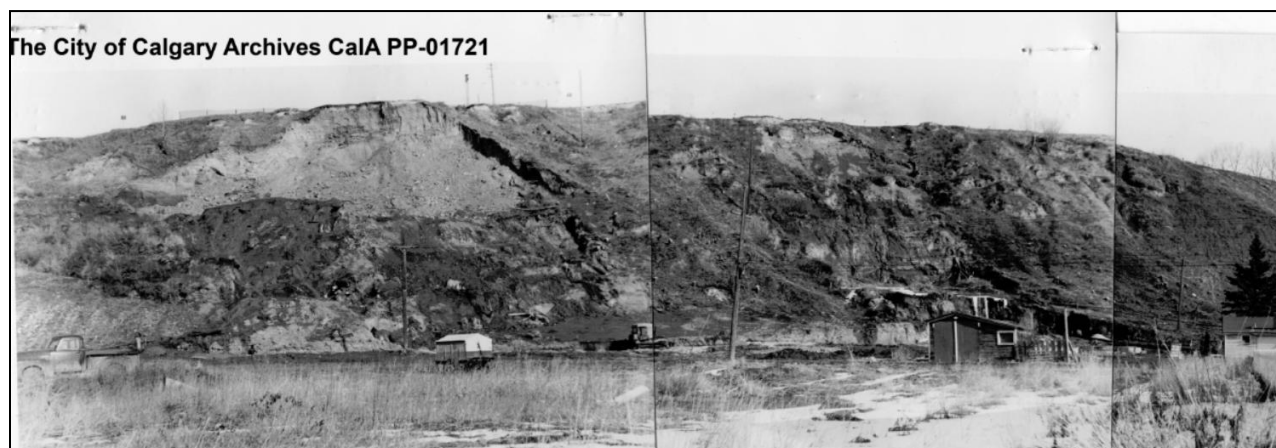
Figure D9. 1958 Slide Photo of McHugh Bluff. The City of Calgary Archives (copyright; cannot be reproduced without obtaining permission of City Archives).

The February, 1958 slide was massive. It was centered at the top of the slope near 5th St. N.W. and fanned-out east to near 4A St. N.W. in Sunnyside and west to the 600 block above 9th Ave. N.W. In

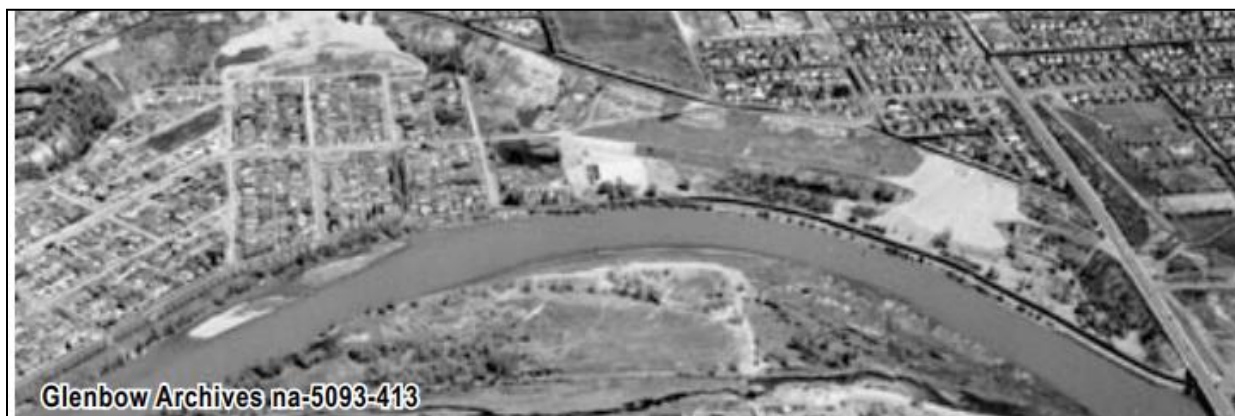
Figure D12. *Glenbow Archives 1967 aerial photo of McHugh Bluff. The remnants of the 1958 slide are still obvious as white coloured area on bluff. As is the area of the 1932 slide - you can see where it covered the low angle tramline path that ran up to Centre Street.*

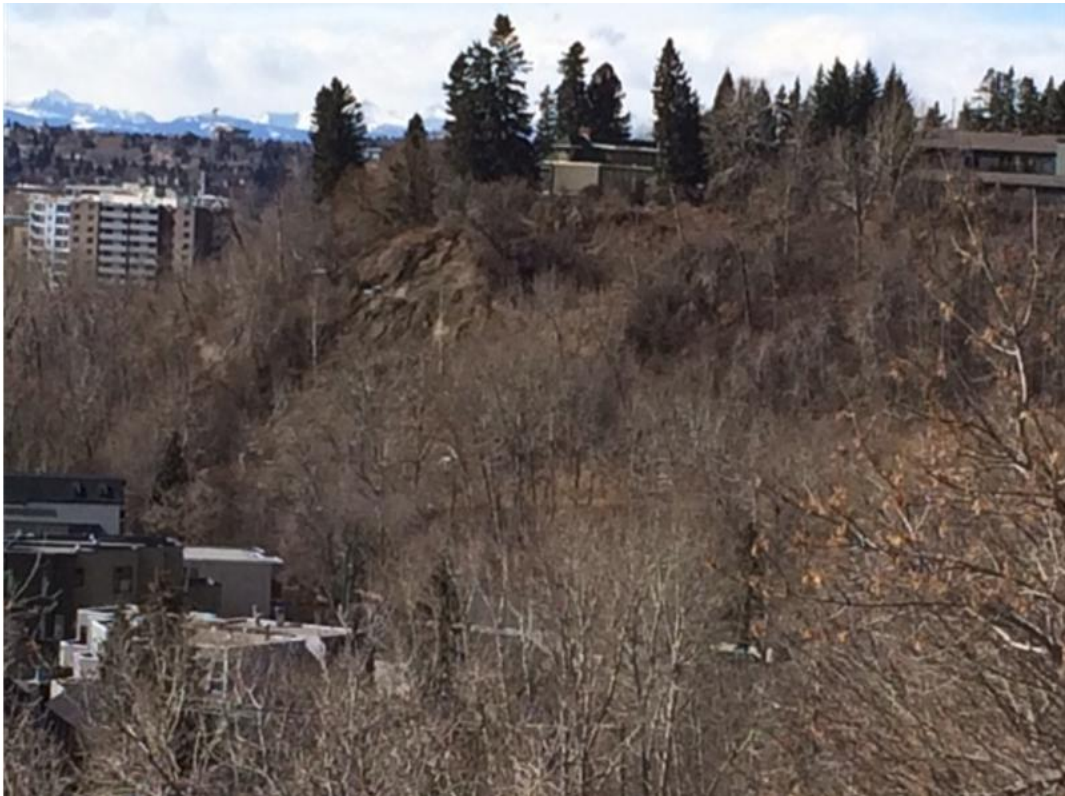
Figure D13. 2021 Slide on east side of 7A St. N.W. Promontory

An October, 2021 slide occurred on the steep slopes on the east side of the 7A St. N.W. promontory. This slide occurred after a prolonged dry spell, contrary to the established models for slide initiation. Cracks on the slopes parallel to the bike path below were observed as early as March, 2021 (Peter Hews, personal communication). The top of the slide is near the top of the slope and extends down

slope to cover the bike path. Engineers have studied the slide, drilling a borehole on the bike path, and made recommendations to the City for an initial mitigation plan. Their report has not yet been released.
